# Air Safety Support International

## Safety Communication Bulletin

### Shaw Aero Devices flush mounted Fuel Caps Part No. 416-50

1/2015

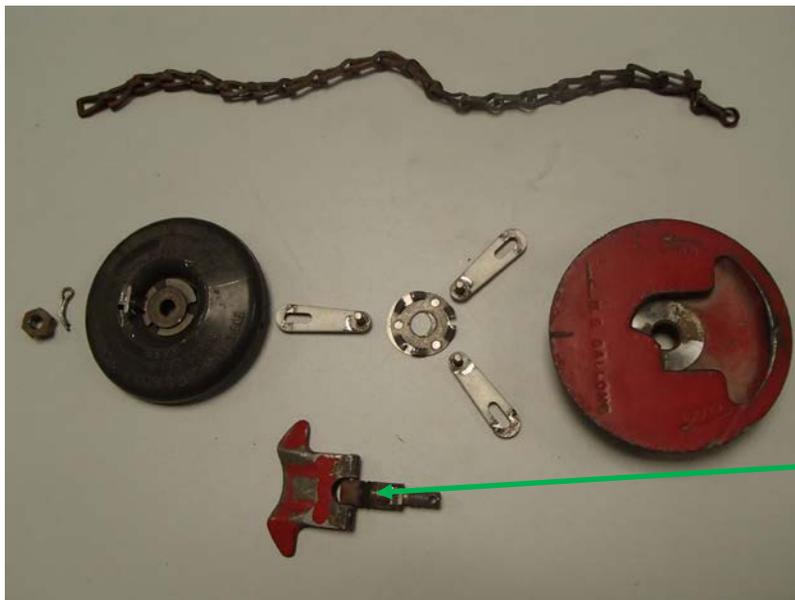
An investigation conducted by ASSI has found that there is limited guidance available for Owners, Operators, Continued Airworthiness Management and Maintenance Organisations as to the inspection frequencies and maintenance practices to ensure that the O-ring seals fitted to Shaw Aero Devices flush mounted fuel caps part no. 416-50 are not cracked and deteriorated. The larger of the two O-ring seals is visible on the main body of the cap, but the smaller O-ring seal located on the shaft of the locking mechanism axle is not visible without dismantling the cap and can be easily missed.

O-ring on the shaft of the locking mechanism axle is not visible when the cap is fully assembled

**If leaks are found to emanate from the fuel cap due to inadequate sealing, the defective cap must be replaced with a new or overhauled cap assembly complete with O-ring seals.**

**In the absence of approved Manufacturer's data detailing how to change and lubricate the O-ring seals and adjust the fuel cap for correct sealing, the O-ring seals should not be removed and replaced by the maintenance Organisation.**
